1st Step Home Inspection Services

Web Pics

Prepared for: *1st Step Home Inspections*

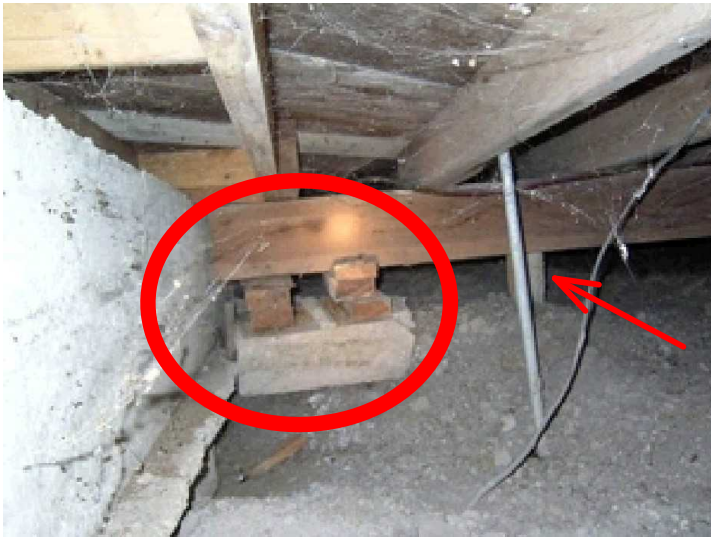
Improperly supported and sagging main beam.

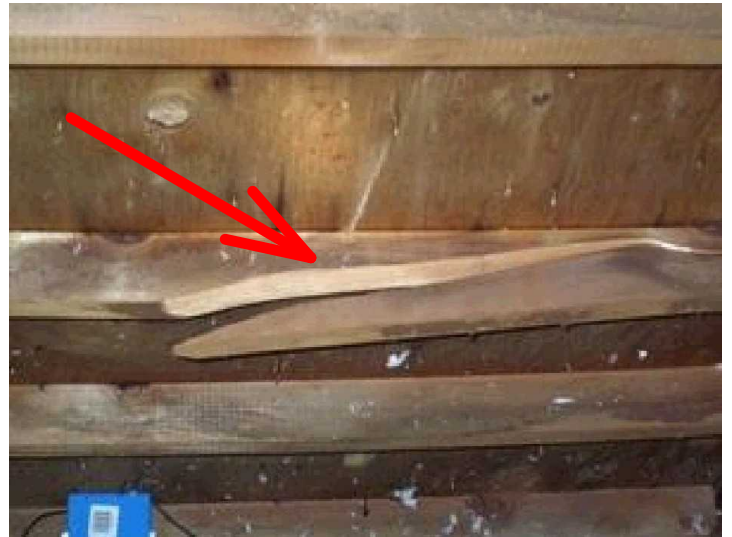
Cracked roof rafter.

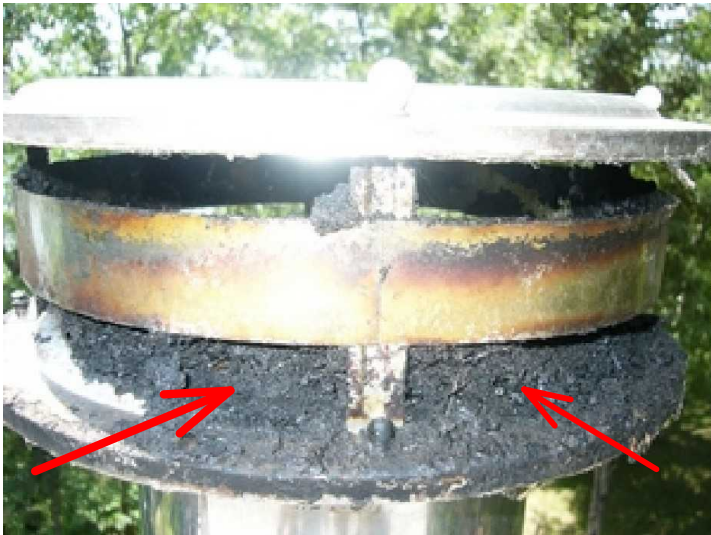
Creosote caked chimney flue poses a fire hazard.

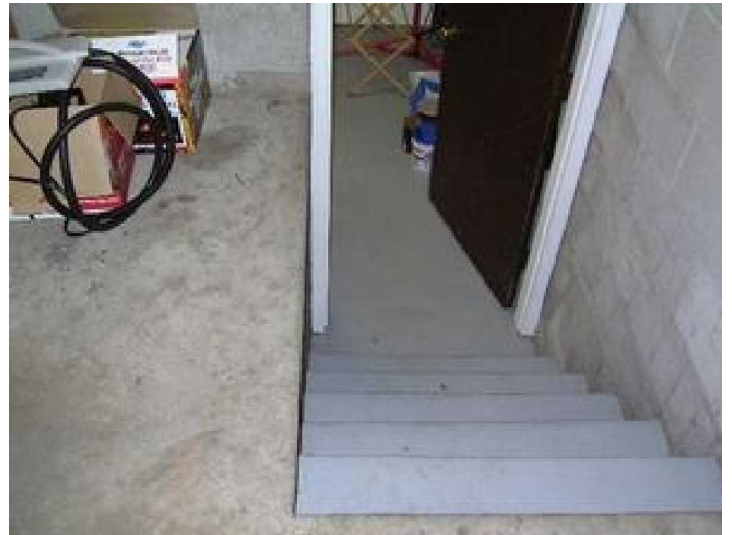
Missing hand rails.

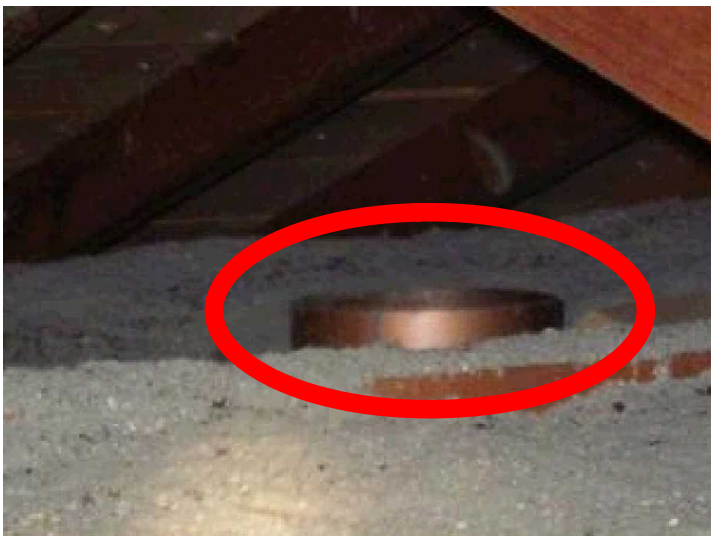
The kitchen exhaust is ducting into the attic.

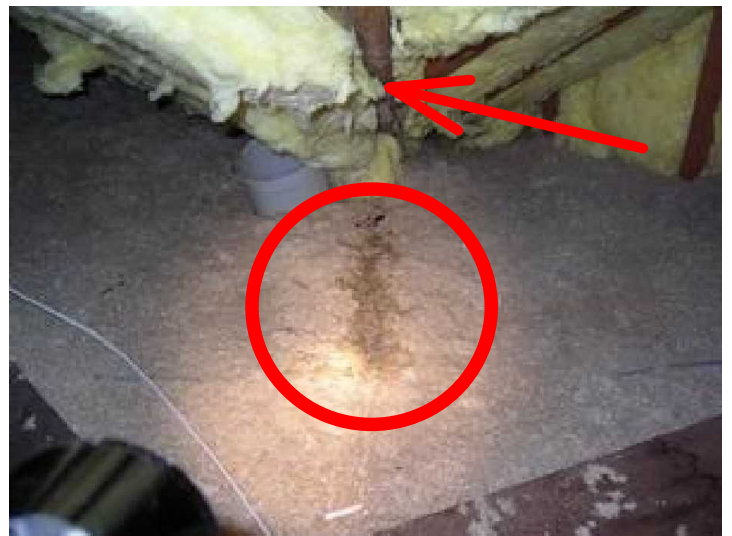
Leaking roof valley.

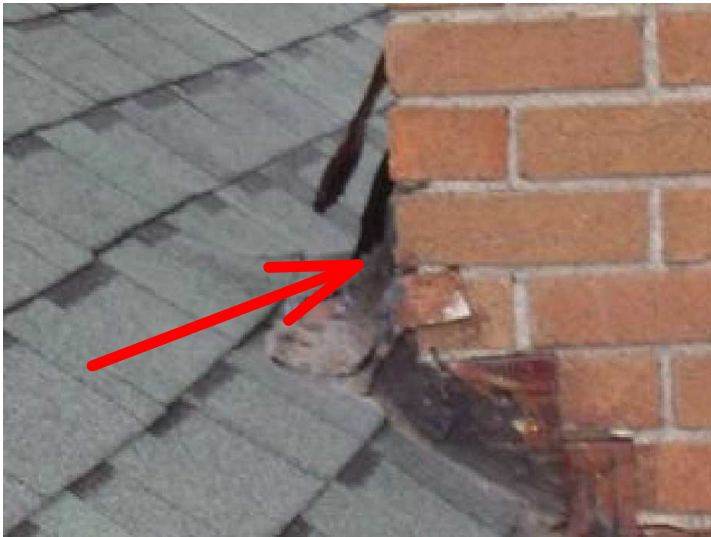
Loose chimney flashing

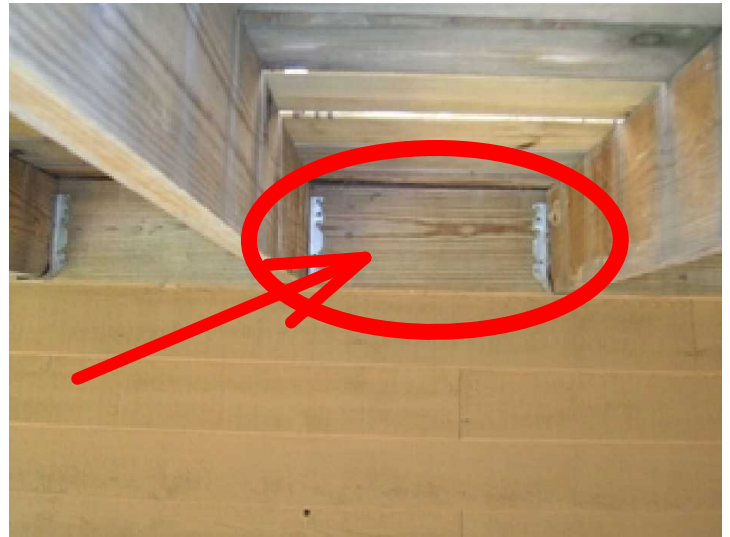
Missing lag bolts on a deck ledger board.

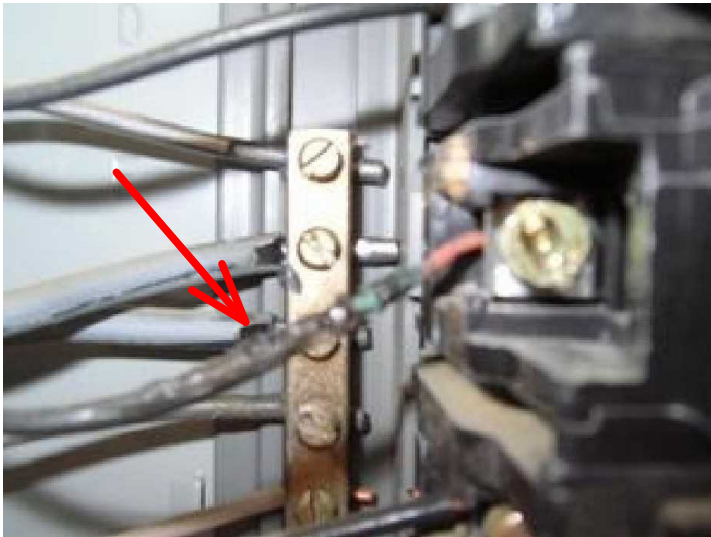
Overheated electrical wires.

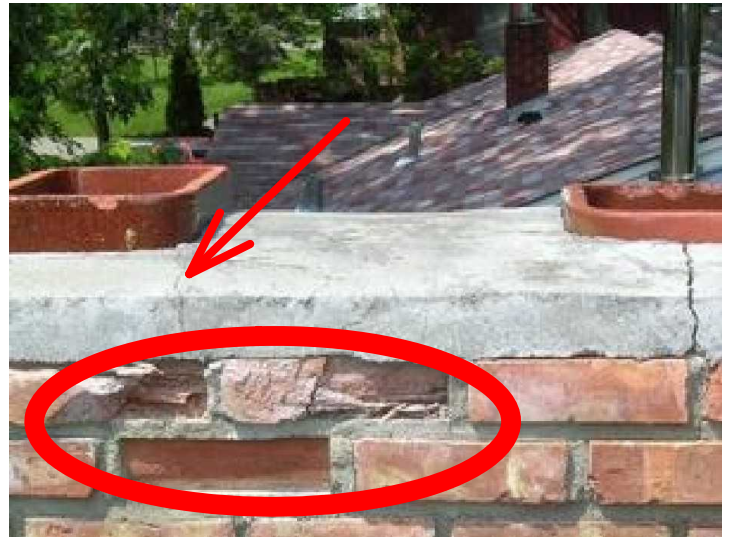
Cracked chimney cap and spalling bricks.

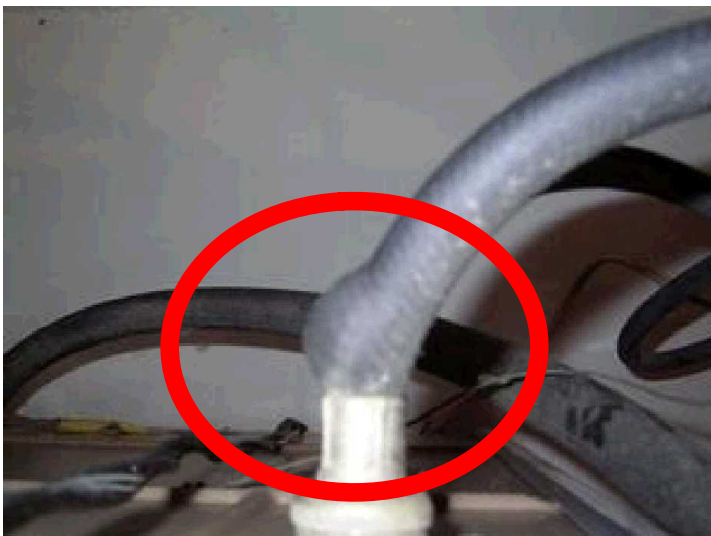
When was the last time you checked your washing machine supply lines.

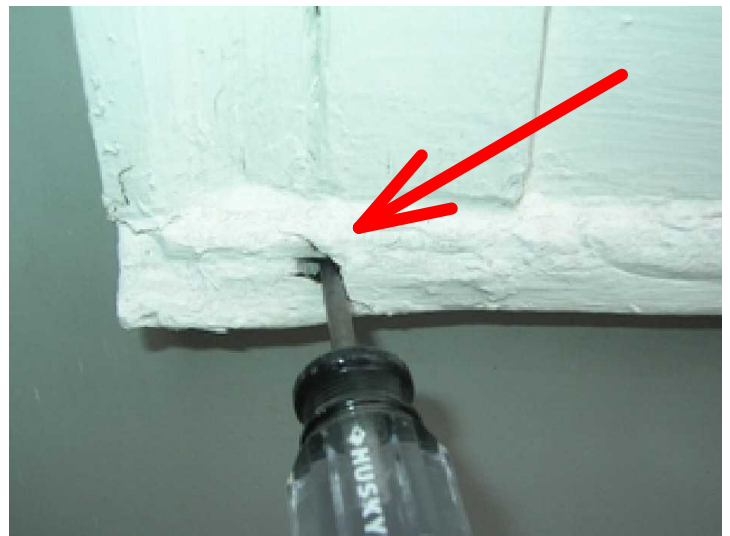
Roted windows painted over.

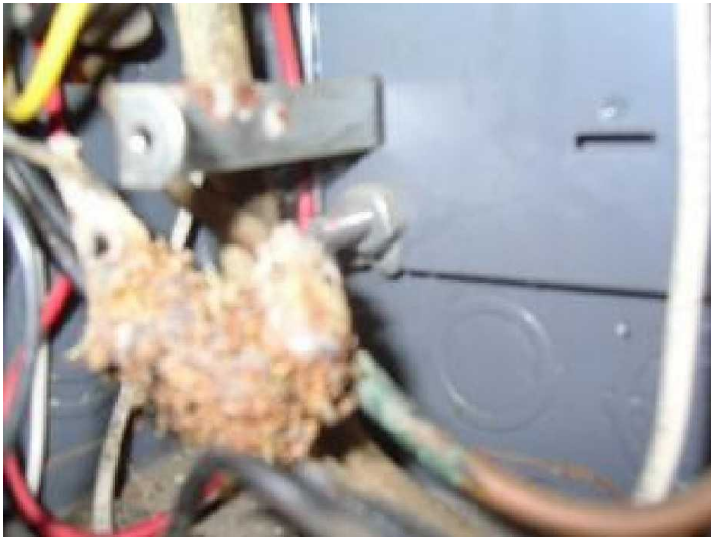
Missing knock outs allow rodent entry

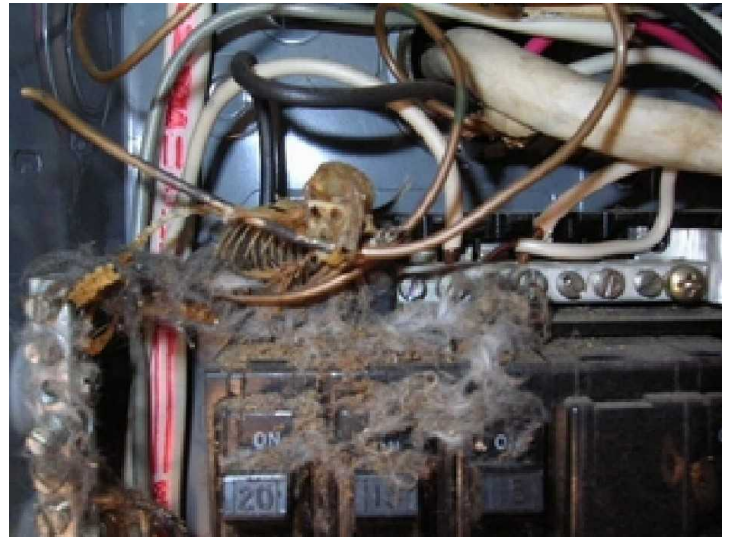
Unwanted guest
